Report

Serious incident on **16 August 2008**
on **take-off from Paris Charles de Gaulle Airport (95)**
to the **Boeing 737-800**
registered **SU-BPZ**
operated by **AMC Airlines**

BEA

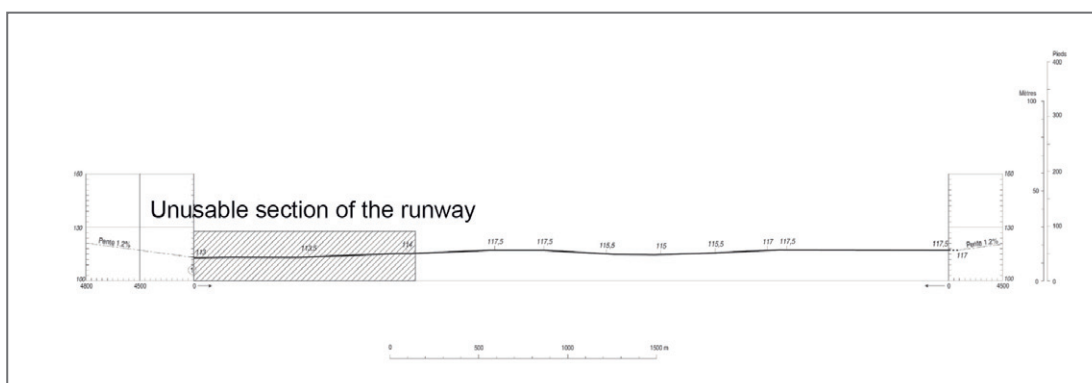
Profile of runway 27L

Repair works on runway 09R/27L were in progress between 4 and 20 August 2008. During this period, the last 1,240 metres of runway 27L were closed for flight operations. The provisional threshold altitude of runway 09R was 376 ft. The profile of runway 27L defined for the duration of the works was characterized by a zero slope in the first two fifths, a depression of around ten feet in the next two fifths and a descent in the last fifth.

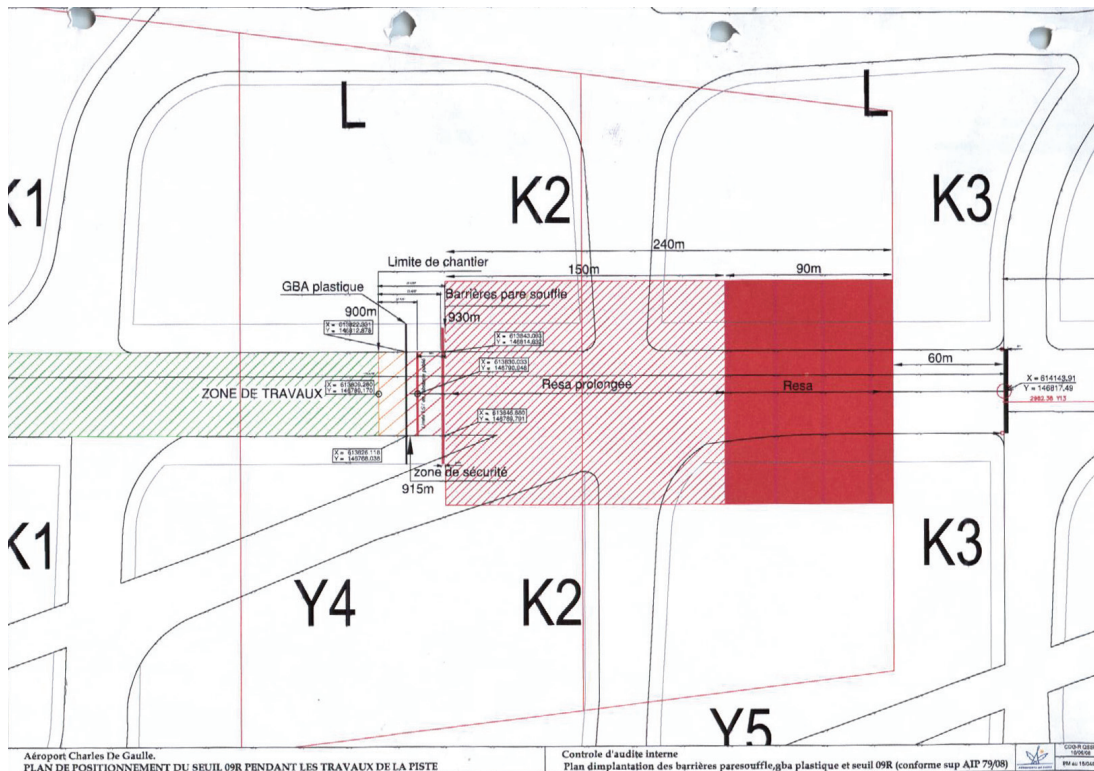
Plan by ADP for an internal audit

⁽¹¹⁾This value is measured from the plan drawn up for the internal audit. A value of 30 m is indicated on the same plan.

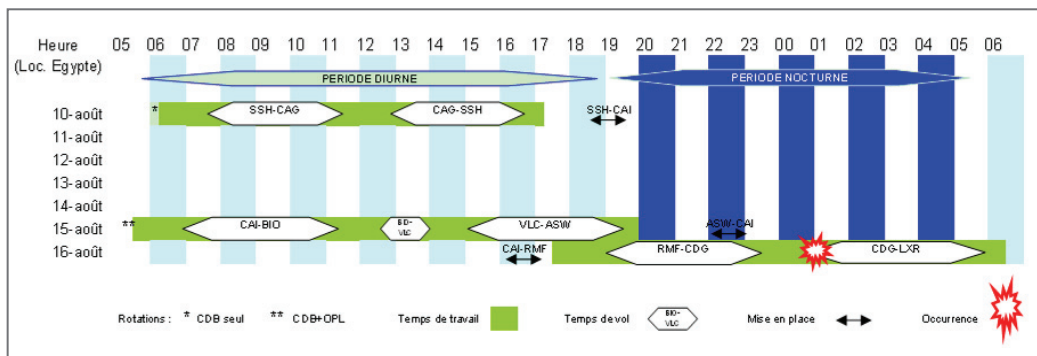
The review of the crew's activity-rest cycles the week preceding the event is summarized in the following table:

The planning for the Marsa Alam – Paris – Luxor trip, delayed until the afternoon as well as the airplane's lateness, made the pilots' activity period clash with their biorhythms in relation to the preceding week. Consequently the time the event occurred corresponded to a period in which the crew's performance was likely impaired.
